Inventory Appendix

Nature Pointe HOA

Grounds

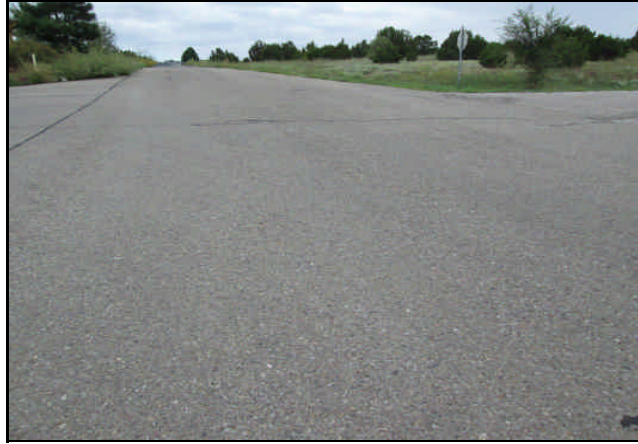
Comp # : 203 Asphalt - Seal/Repair Quantity: Approx 330,000 Sq Ft
Location : Streets throughout community (including Avenida Allegre, which is outside the vehicle gates)
Funded? : Yes

History : Asphalt has not been sealed since installation in 2007.

Evaluation : It is recommended to seal asphalt within a couple years after installation. Recommend planning to seal in the near future. Seal coat asphalt surfaces periodically to prevent premature cracking and deterioration.

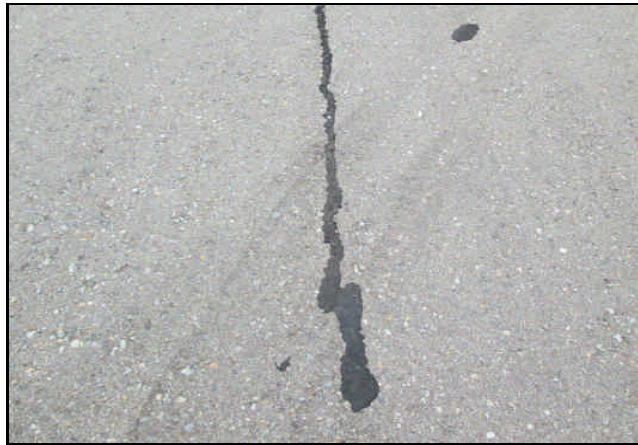
Comp # : 205 Asphalt - Crack Fill Quantity: Approx 356,800 Sq Ft
Location : Streets throughout community (including Avenida Allegre, which is outside the vehicle gates); Clubhouse parking lot
Funded? : Yes

Evaluation : The association plans to crack fill the asphalt annually.

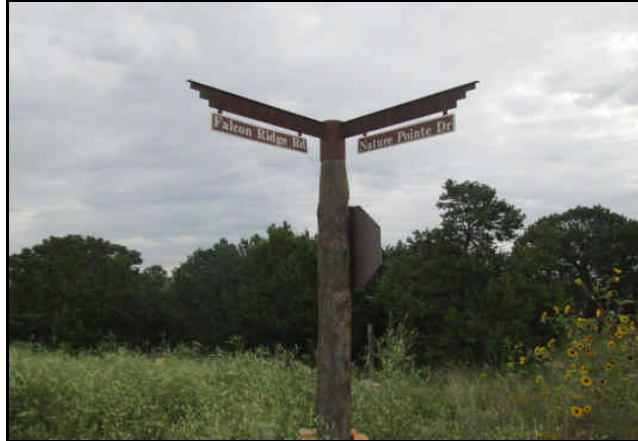
Comp # : 250 Street Signs - Replace

Evaluation : Composed of wood posts with metal vanes and signs. Observed to be in nice shape. Future replacement should be anticipated.

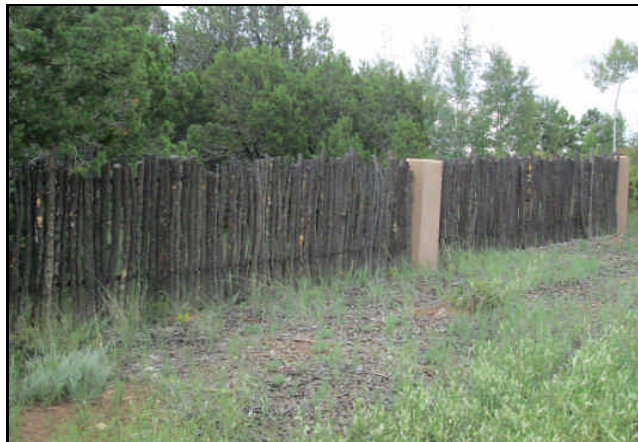
Comp # : 509 Coyote Fence - Replace Quantity: Approx 600 LF
Location : Adjacent to community entrance
Funded? : Yes
History : Installed during 2007.
Evaluation : Still appears to be in good shape overall. Funding is provided for future replacement.

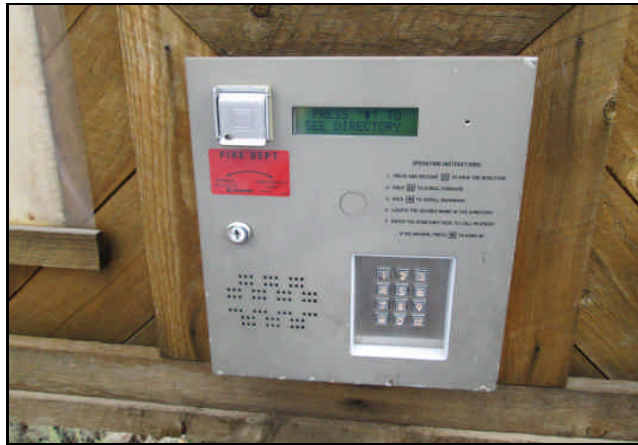
Comp # : 703 Entry System - Replace

Evaluation : Observed to be functional and in fair shape. Future replacement should be anticipated.

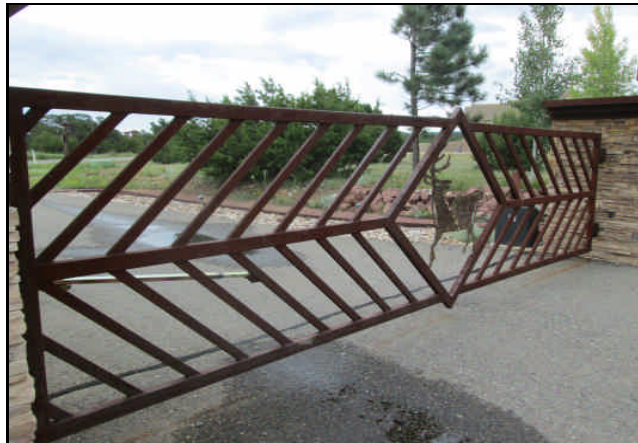
Comp # : 708 Vehicle Gates - Replace Quantity: (4) Vehicle, (1) Ped.

Evaluation : Long life expectancy under normal circumstances. It would still be prudent to plan for replacement eventually of the (4) vehicle gates and (1) pedestrian gate.

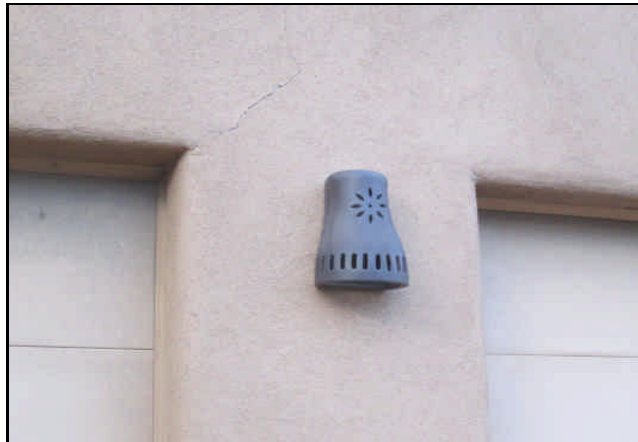
Comp # : 324 Exterior Lights - Replace Quantity: Approx (33) Lights
Location : Mounted to exterior of Clubhouse & Maintenance buildings
Funded? : Yes

Evaluation : Lights are a combination of wall mounted and hanging fixtures. Still decorative and in nice shape. Complete replacement should be expected eventually to update and modernize the appearance.

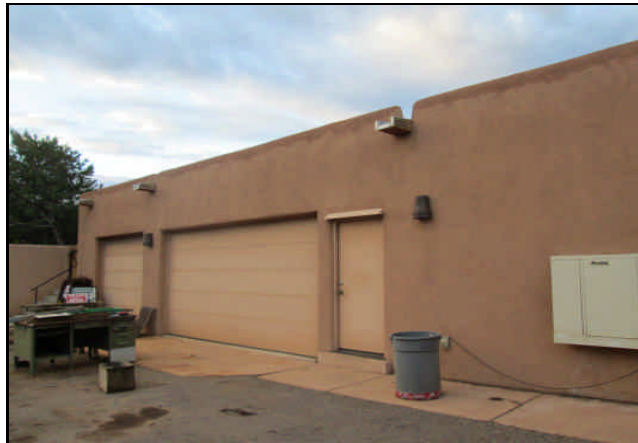
Comp # : 501 Garage Doors - Replace Quantity: (2) Doors
Location : Maintenance Building
Funded? : Yes

Evaluation : Still in good shape. Funding is provided for future replacement.

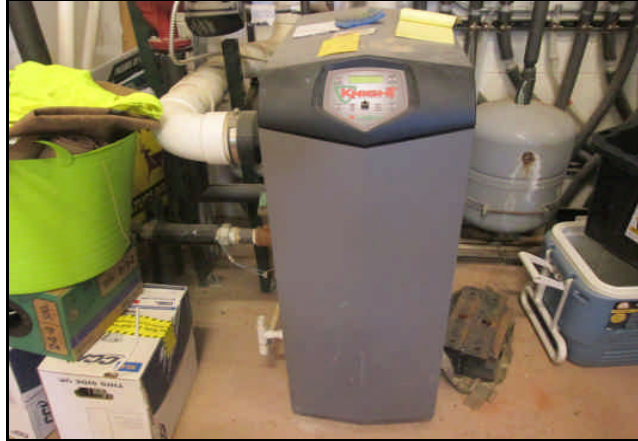
Comp # : 870 Boiler - Replace

Evaluation : Appears clean and in good shape. Future replacement should be anticipated.

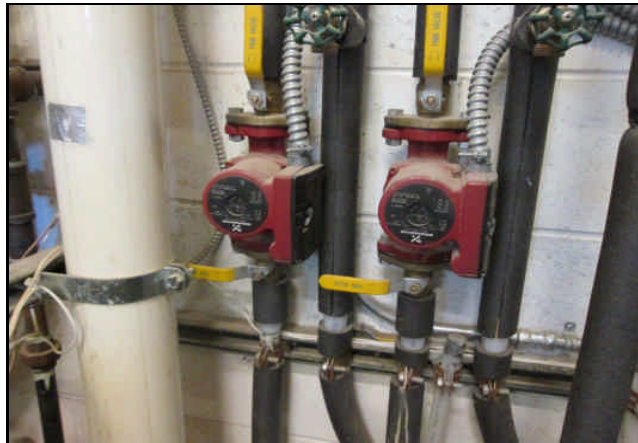
Comp # : 876 Circulating Pumps - Replace Quantity: (18) Grundfos

Evaluation : There are (17) smaller pumps and (1) larger pump. Assumed to be functional and in fair shape. Treat individual replacements as an Operating expense. Funding is provided for complete replacement eventually.

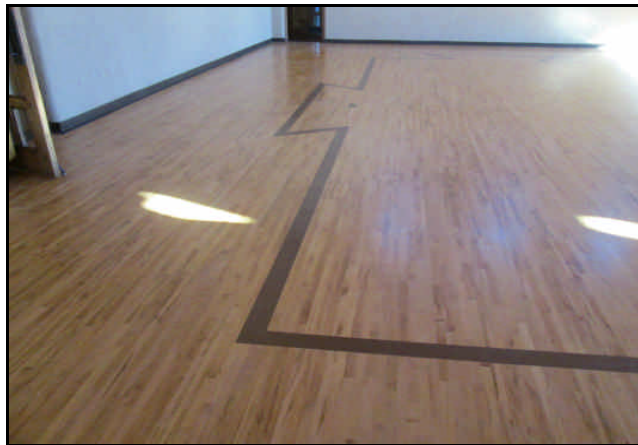
Comp # : 904 Wood Floor - Replace Quantity: Approx 3,700 Sq Ft
Location : Anasazi Hall & racquetball court
Funded? : Yes

Evaluation : Long life component under normal circumstances. It would still be prudent to plan for replacement eventually. Life span assumes periodic refinishing and maintenance will be completed.

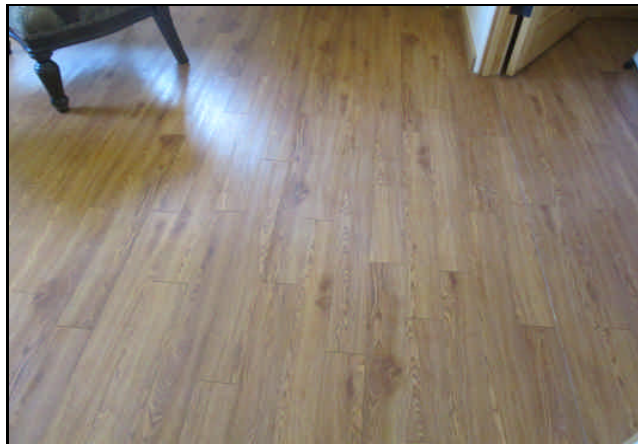
Comp # : 907 **Laminate Wood Floor - Replace**

Evaluation : Floor appears to be in good shape with minimal use. Future replacement should be anticipated.

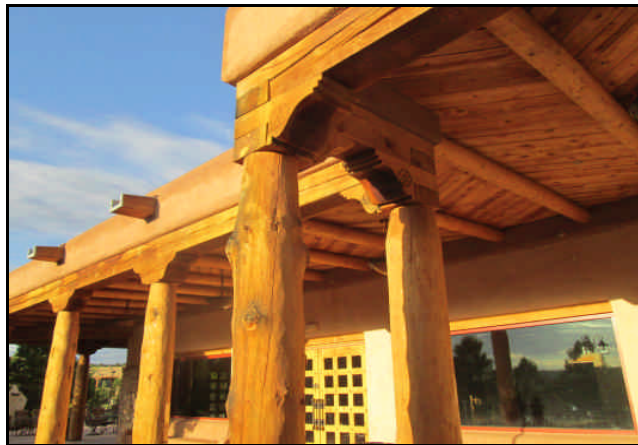
Comp # : 1116 Wood Surfaces - Stain Quantity: Trim, Doors, Beams, Etc.
Location : Clubhouse & Maintenance Building exteriors; Wood fence & gates
Funded? : Yes

Evaluation : The association reportedly uses penofin to stain the wood surfaces. Treat annual touch-ups as an Operating expense. Funding is provided to stain all wood surfaces at the same time to maintain a uniform appearance.
