Inventory Appendix

Nature Pointe HOA

Grounds

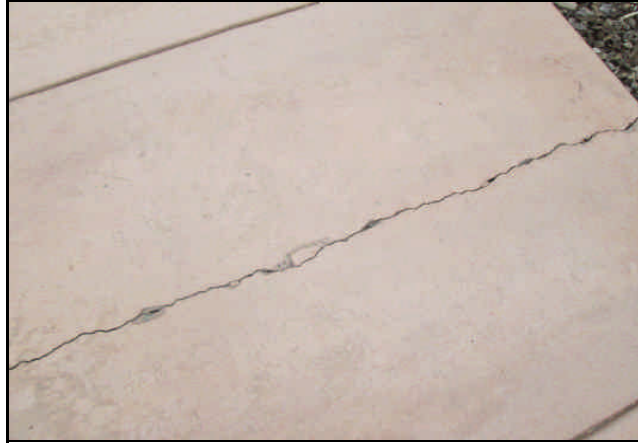
Comp # : 103 Concrete - Repair Quantity: Numerous Sq Ft
Location : Common area walkways, basketball court, indoor pool deck
Funded? : Yes

Evaluation : There is no expectancy to completely replace the concrete. This component provides an allowance for periodic repairs and/or partial replacements. Some cracks noted.

Allowance for repairs and/or partial replacement

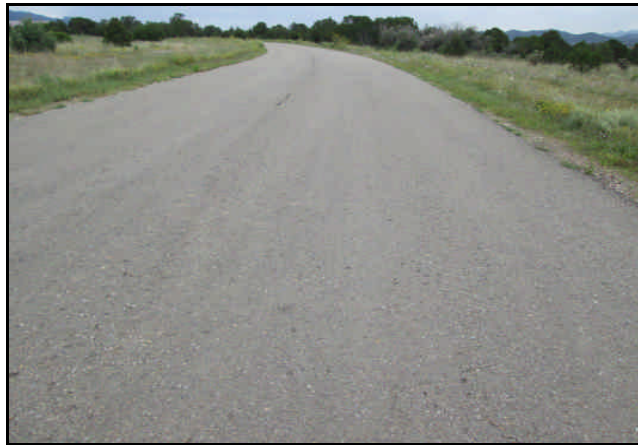
Comp # : 201 Asphalt - Resurface Quantity: Approx 330,000 Sq Ft
Location : Streets throughout community (including Avenida Allegre, which is outside the vehicle gates)
Funded? : Yes

Evaluation : Some cracks noted. Still generally smooth and in good shape overall. Life span is based on periodically seal coating and maintaining the surface.

Estimate to resurface

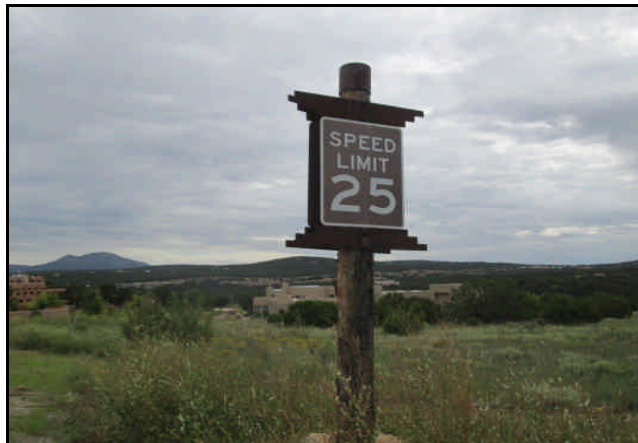
Evaluation : The association should stain the wood surfaces every couple years as a maintenance expense to protect the surfaces and maintain the appearance. This component provides an allowance for repairs, which may include replacing posts, vanes, signs, etc.

Best Case: \$2,200
Allowance to refurbish

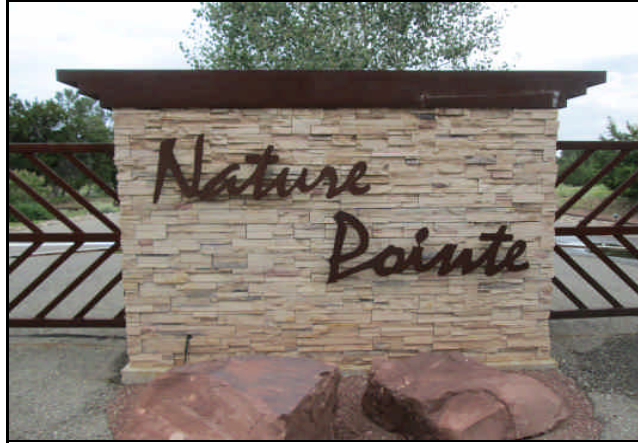
Evaluation : Funding is provided to eventually replace (3) metal signs and repair (3) wood structures. Still decorative and in nice shape.

Best Case: \$9,000
Estimate to refurbish

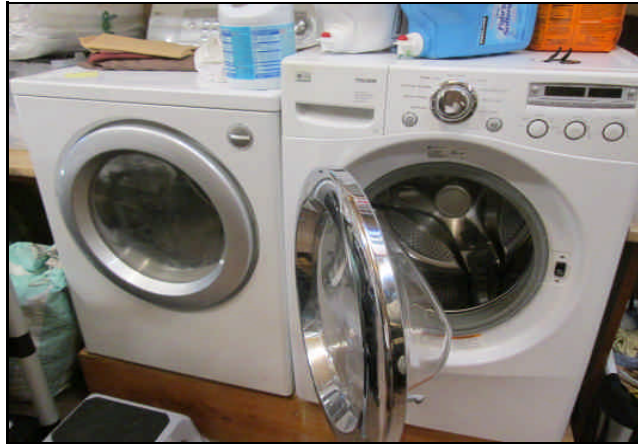
Comp # : 850 Washer/Dryer - Replace

Evaluation : Assumed to be functional with no problems reported. Future replacement should be expected.

Best Case: \$1,600
Estimate to replace

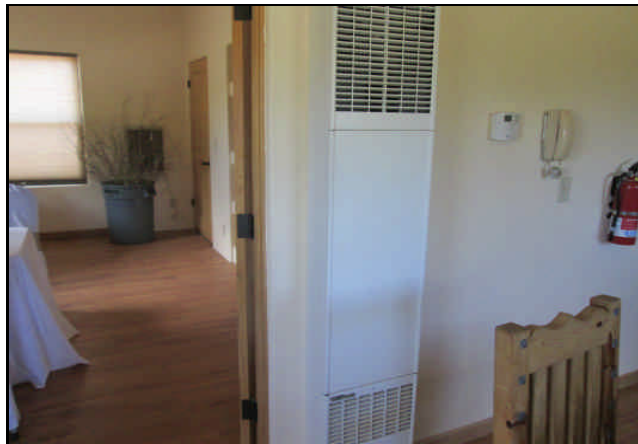
Comp # : 865 Gas Furnace - Replace

Evaluation : Assumed to be functional with no issues reported. Funding is provided for future replacement.

Best Case: \$1,300
Estimate to replace

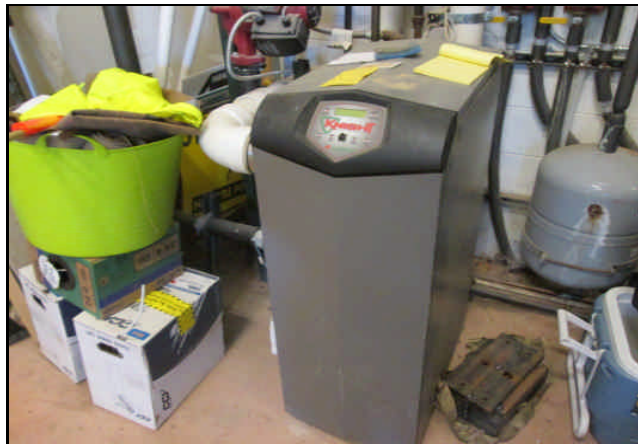
Evaluation : This component provides funding to replace the heat exchanger in-between boiler replacement intervals.

Allowance to refurbish

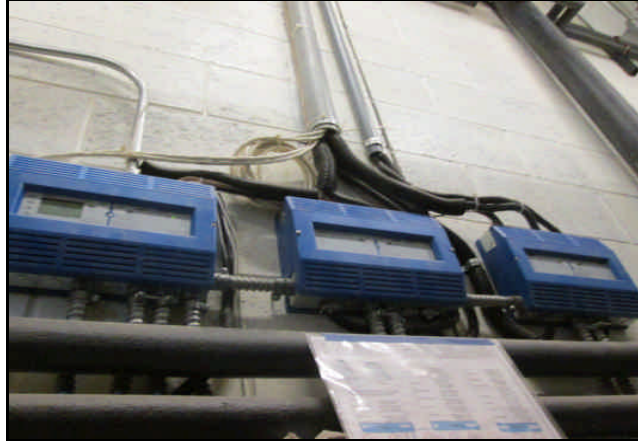
Comp # : 874 Boiler Control Modules - Replace Quantity: (3) Tekmar

Evaluation : No problems reported. Future replacement should be anticipated. Model: 325 and 422.

Best Case: \$1,600
Estimate to replace

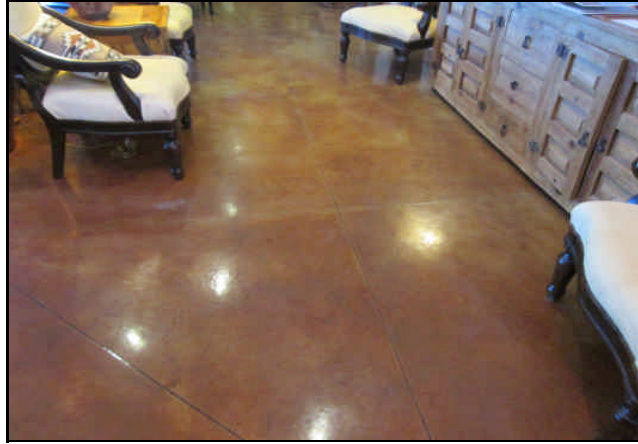
Evaluation : This is a stained concrete floor. Periodic recoating should be expected to maintain the color and appearance. Surfaces have not been recoated since installation.

Best Case: \$13,000
Estimate to seal

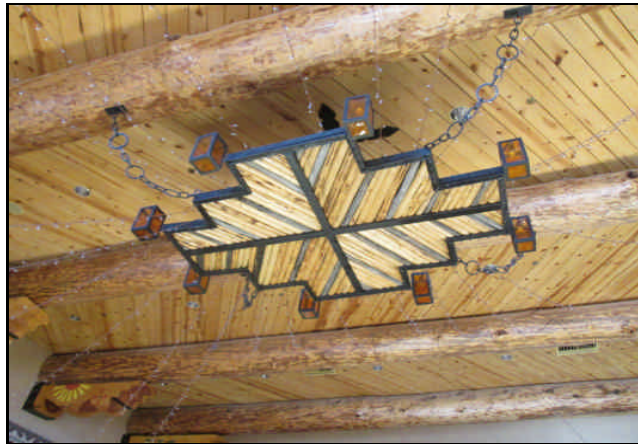
Comp # : 910 Interior Lights - Replace Quantity: Approx (200) Lights
Location : Throughout Clubhouse, Apartment Unit, & Maintenance Building interior
Funded? : Yes

Evaluation : Lights are a combination of recessed can, fluorescent, hanging, and chandelier fixtures. Decorative and in nice shape. Complete replacement should be expected eventually to update and modernize the appearance.

Best Case: \$26,000
Estimate to replace

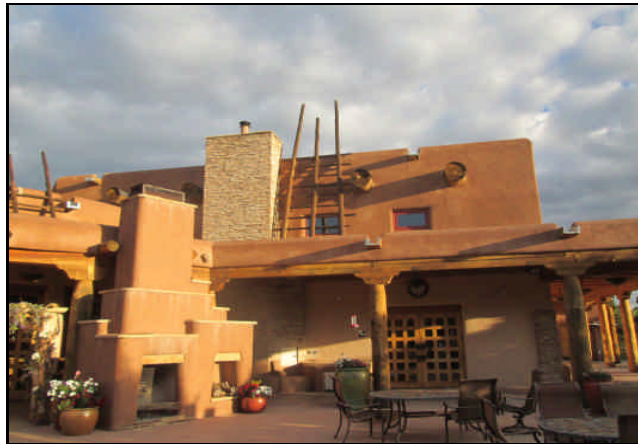
Evaluation : Funding is provided to eventually re-stucco the exterior of the clubhouse, maintenance building, and walls. Some cracks and chipping noted. Overall fair conditions observed.

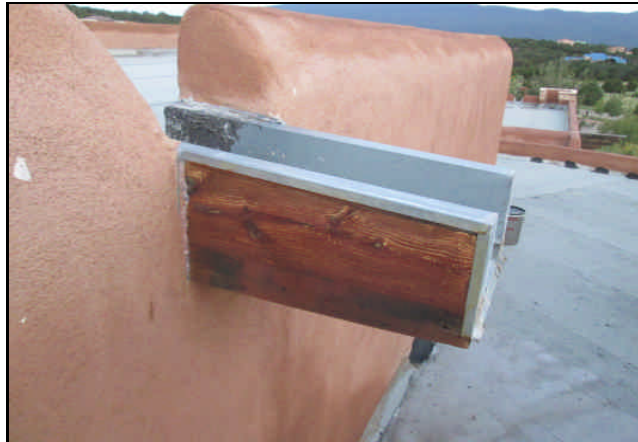
Comp # : 1125 Wood Surfaces - Repair

Evaluation : The building exteriors have numerous wood canales and beams. They are capped with metal, which will help extend the life span. The association should still expect a large replacement and repair project eventually. An allowance is provided for future repairs and replacements.

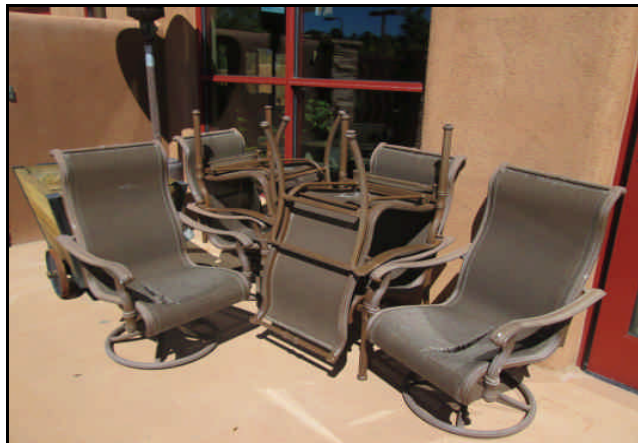
Comp # : 1217 Pool Furniture - Replace

Evaluation : Use and wear evident. Frayed and torn mesh slings noted. Pieces include (15) lounges, (18) chairs, (5) tables, and (16) ottomans.

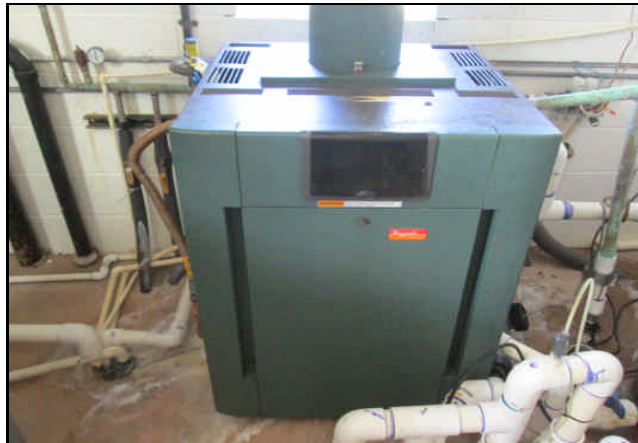
Comp # : 1222 Pool Heater - Replace

Evaluation : Based on age, heater should be nearing time for replacement. Model: CR406A, Serial: 0710272352.

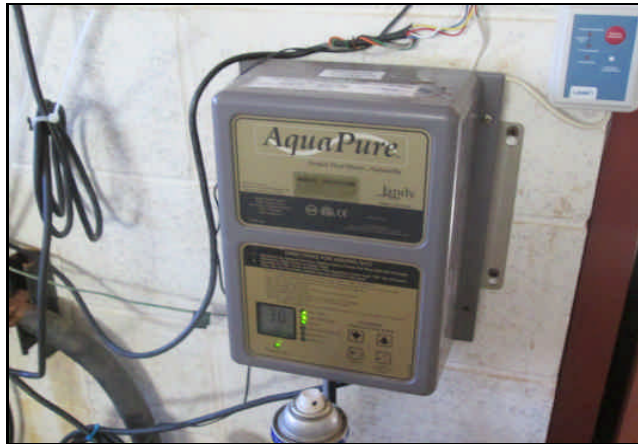
Comp # : 1230 Chlorinator - Replace

Evaluation : The association is reportedly researching replacement options, so we assume this salt water chlorine generator will be replaced in the near future. Remaining life reflects replacement during 2014. Model: APURE1400.

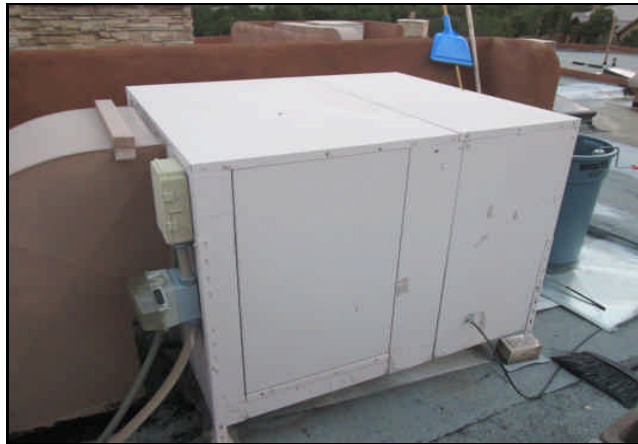
Comp # : 1350 Evaporative Coolers - Replace (A) Quantity: (11) MasterCool
Location : (10) at Clubhouse rooftop & (1) mounted to side of Maintenance Building
Funded? : Yes

Evaluation : Clubhouse has ASA50 and ASA70 model units. The maintenance building has a SWMC3000B model. Appear to be in fair shape with some exterior fading noted.

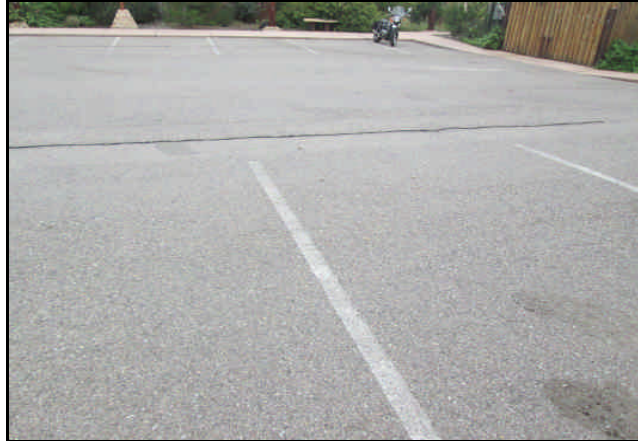
Evaluation : Some cracks noted. Still generally smooth and in good shape overall. Life span is based on periodically seal coating and maintaining the surface.

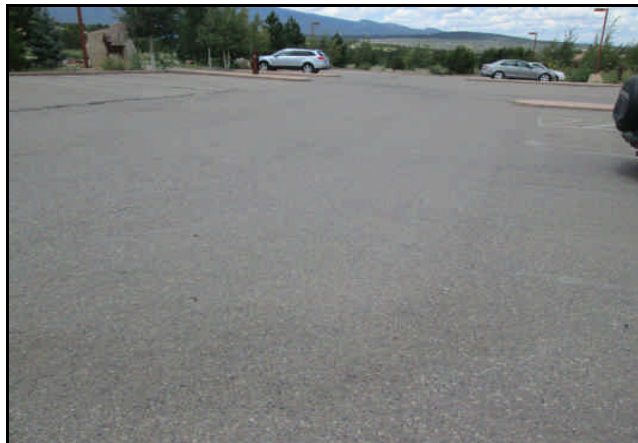
Comp # : 232 **Parking Lot - Seal/Repair** Quantity: Approx 26,800 Sq Ft

Evaluation : It is recommended to seal asphalt within a couple years after installation. The association plans to seal the clubhouse parking lot before the end of 2014. Seal coat asphalt surfaces periodically to prevent premature cracking and deterioration.

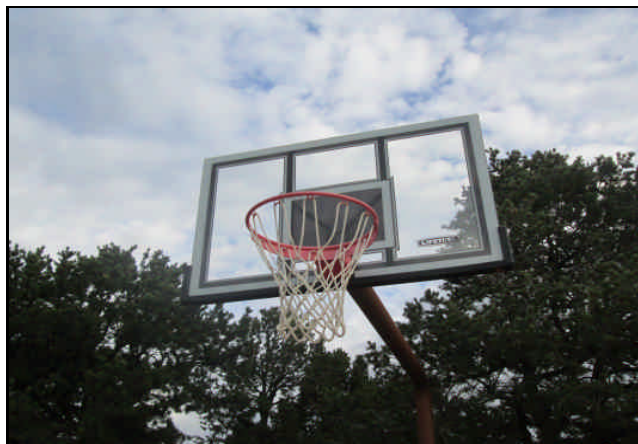
Comp # : 435 Basketball Goals - Replace Quantity: (2) LifeTime Goals
Location : (1) at recreation area & (1) at Anasazi Hall
Funded? : Yes
History : Installed during 2007.
Evaluation : Still in nice shape. Future replacement should be anticipated.

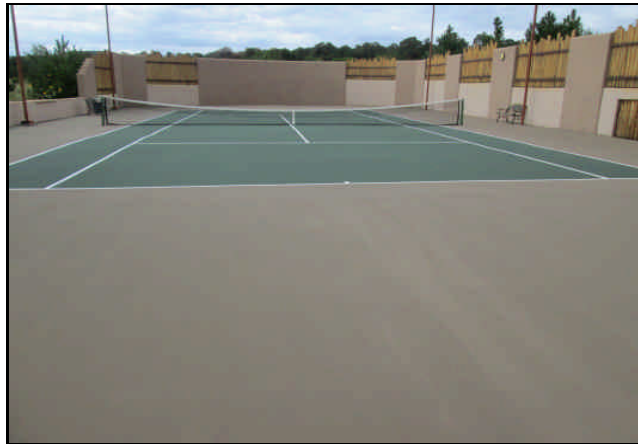
Comp # : 440 Tennis Court - Replace Quantity: (1) Court
Location : Recreation area
Funded? : Yes

Evaluation : This is an asphalt based court. Generally smooth and in good shape overall. Some cracks noted around the perimeter of the court. Life span is based on periodically resurfacing and maintaining the court.

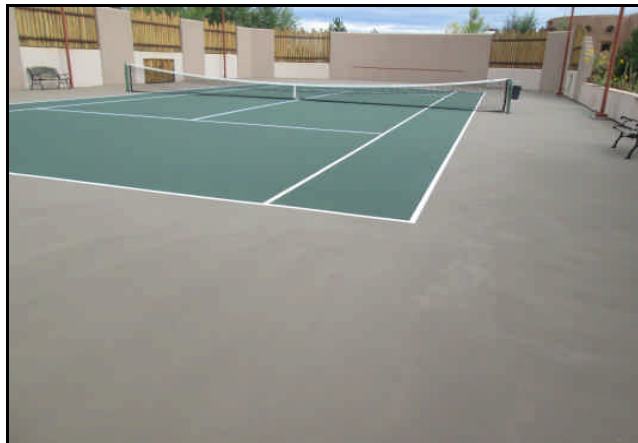
Evaluation : Cost reportedly included additional work for crack repairs. Good conditions observed. Periodic resurfacing should be expected.

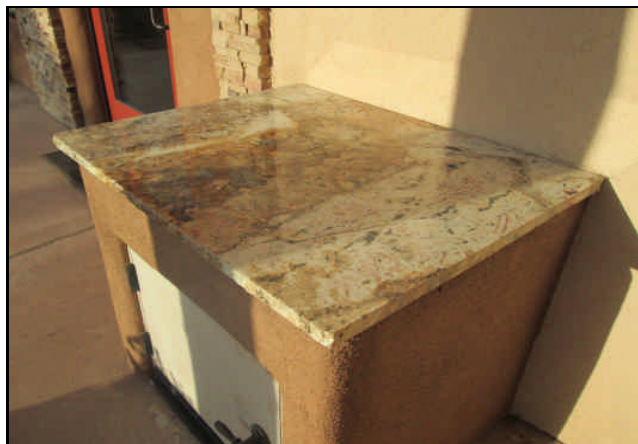
Comp # : 470 Countertops - Remodel Quantity: (3) Countertops
Location : Clubhouse rear patio
Funded? : Yes
History : Installed during 2007.
Evaluation : Countertops are a combination of tile and granite. There is also (1) sink. Future replacement should be anticipated.

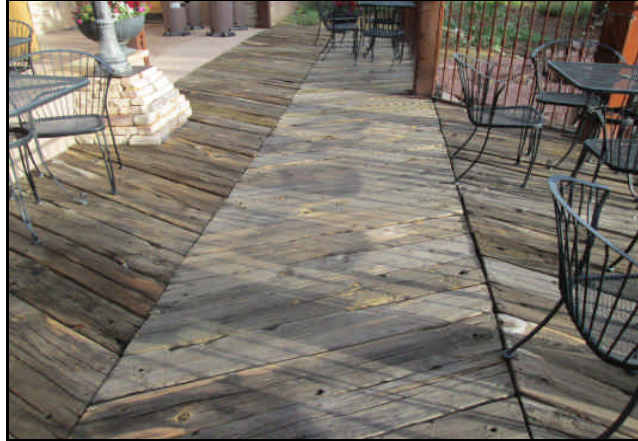
Evaluation : Long life component, however future replacement should still be anticipated.

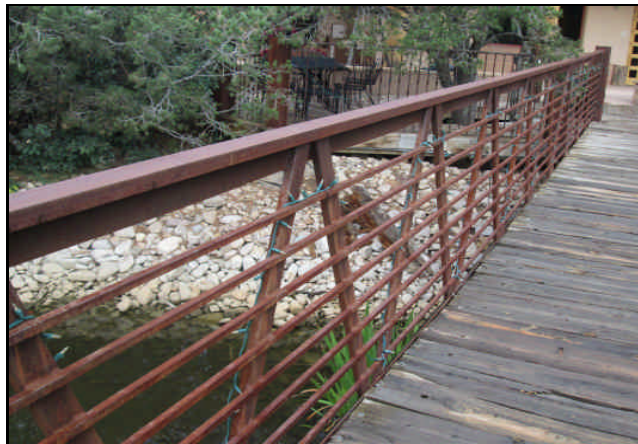
Evaluation : Observed to be stable and in good shape. It would be prudent to plan for replacement eventually.

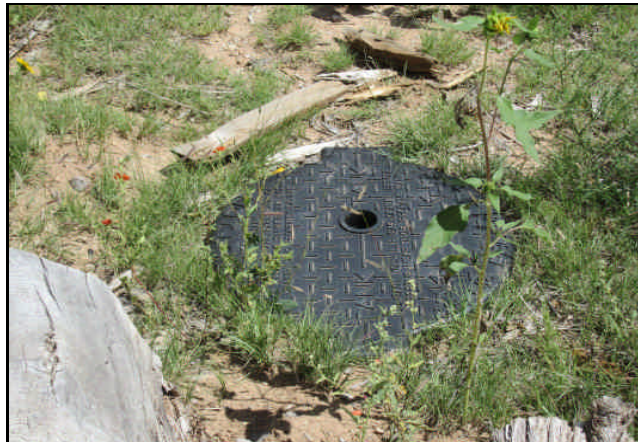
Evaluation : Tanks are underground and not accessible for inspection. No problems reported. Future replacement should be anticipated.

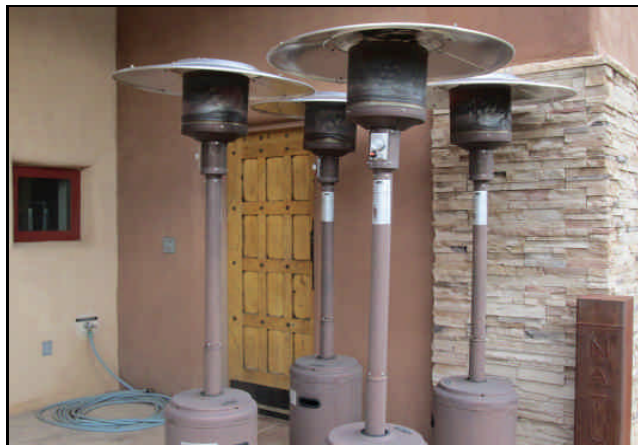
Evaluation : Assumed to be functional. Funding is provided for future replacement.

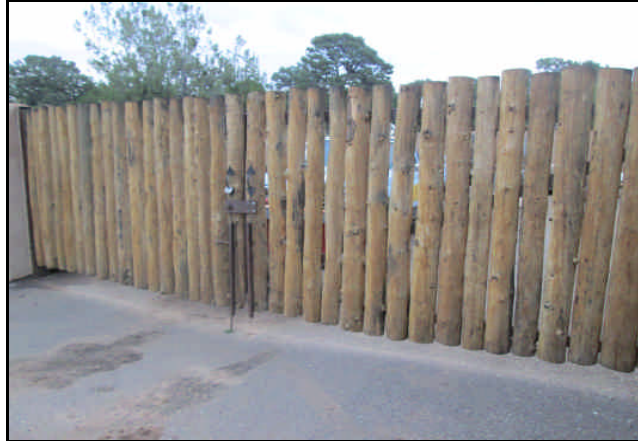
Evaluation : Good conditions observed. Funding is provided for future replacement. Funding to stain the wood surfaces periodically is included with the clubhouse surfaces.

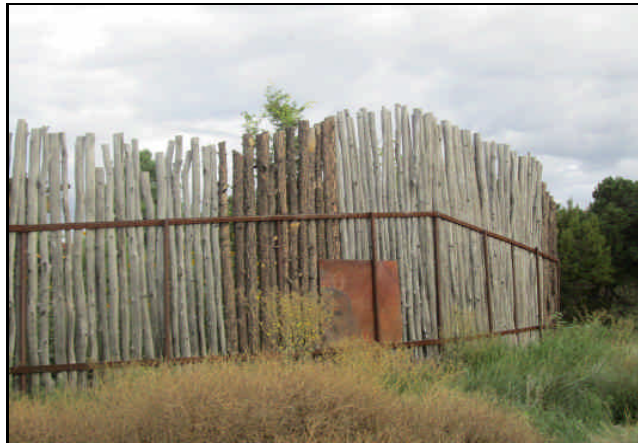
Evaluation : Still appears to be in good shape overall. Funding is provided for future replacement.

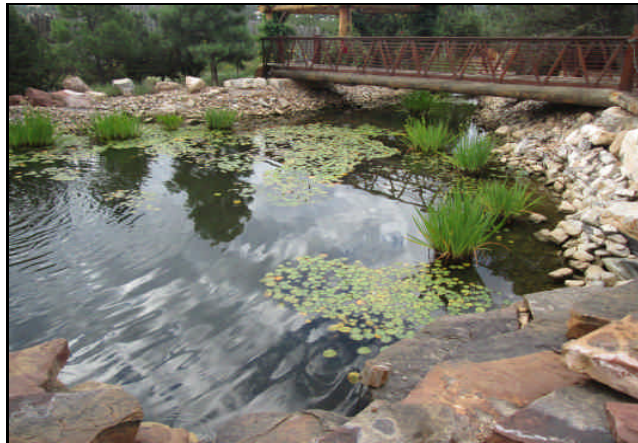
Evaluation : This component provides an allowance to eventually refurbish the Nature Pond. This may include liner repairs, lighting replacement, waterfall repairs, etc.

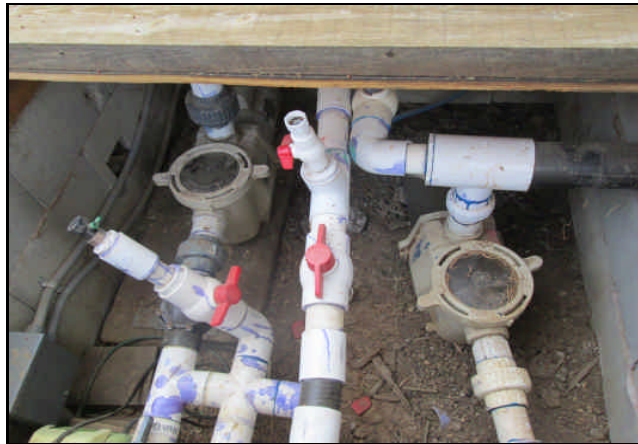
Evaluation : Periodic repair and motor replacement should be addressed as a maintenance issue. This component funds for replacement of the pump and motor assembly.

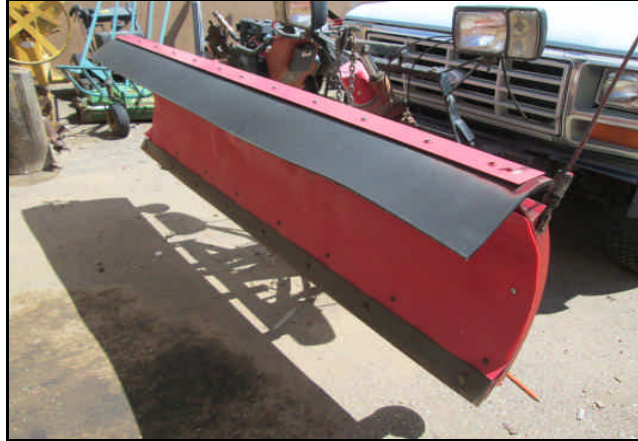
Evaluation : Funding is provided for future replacement. Blade measures 6'-6". Model: 60214.

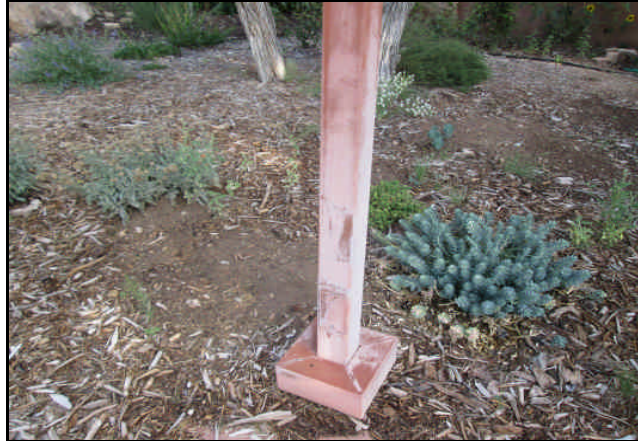
Evaluation : Surfaces appear generally faded and oxidized. Recommend planning to repaint in the near future. Periodic repainting should be expected to maintain the appearance and to inhibit rust.
